Semester Thesis

Design of an Automated Aging Analysis for the Motherboards in the CMS ECAL

Spring Term 2018

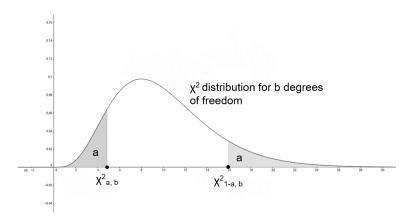
Figure 1.4: χ^2 CDF (unedited image from https://www.geogebra.org/m/p5GKdHnA). Both areas shaded in gray amount to *a*. The parameter *b* states the degrees of freedom of the χ^2 function.

CL is the level of confidence with which it can be claimed that the MTTF is not lower than MTTF_{low} or not higher than MTTF_{upp} . The expression $\chi^2_{a, b}$ stands for the inverse χ^2 CDF, where *a* is the argument (the area under the χ^2 PDF) and *b* the degrees of freedom of the χ^2 function (see Figure 1.4).

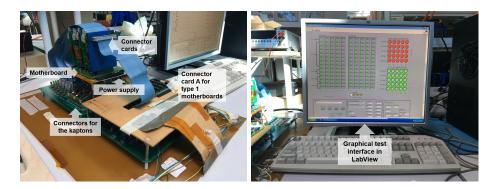
Figure 2.2: Setup for the interconnection test. On the left, the holder for the motherboard as well as the different ribbons and cables that need to be plugged into the motherboard are displayed. The right picture shows the user interface based on the program LabView.

The interconnection test setup was built by the particle physics group from the INFN Torino and simply reused in this study. The tested motherboard is placed on the designated holder. Then, the connector cards are plugged in and the motherboard's kaptons are placed in connector bars below the motherboard holder. For motherboards of type 1, the connector card A (the one with the shortest connection ribbon) is replaced with a different card (labeled "Type 1"). As a last step, the cable coming from the power supply is plugged into the motherboard. The whole test setup and the user interface, discussed in the next subsection, are displayed in Figure 2.2.

The user interface of the test setup built by the particle physics group from the INFN Torino is displayed on the right in Figure 2.2. It is based on the software

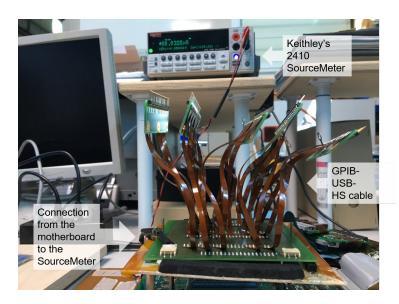
Figure 2.4: Setup for the leakage current test. The measurements are performed by Keithley's 2410 SourceMeter that is able to simultaneously provide a DC output voltage and then measure the resulting leakage current in the motherboard. The measurements are coordinated by the script Leakage Current Test Measurement.ipynb.

At the core of the leakage current test setup lies Keithley's SourceMeter 2410. It is able to simultaneously apply a DC output voltage and measure the resulting current. The power supply port of the tested motherboard has to be connected to the "Input/Output" port of the sourcemeter. The connection from the sourcemeter to the computer that controls the measurements can be achieved via National Instruments' "GPIB-USB-H" cable. In order for the computer to be able to communicate with the sourcemeter, the installation of National Instruments' driver software "NI-488.2" is necessary. Unfortunately only Windows and some versions of Linux are supported. The test setup is shown in Figure 2.4.

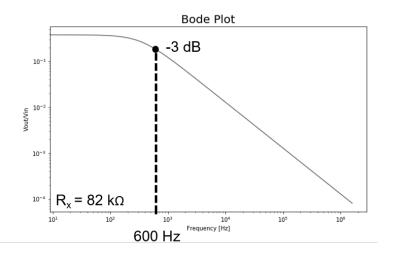
Figure 2.7: Bode plot for the low-pass filter on the motherboards. Note that a logarithmic scale was chosen for both axes. While low frequencies are transmitted with almost no losses, higher frequencies are suppressed or completely extinguished.

which is also increasing when R_x is increasing. To achieve a reasonable difference (e.g. on the order of 1 V) in V_{out} between the cases when the low-pass filter is working to when it is not working, a resistivity $R_x = 82 \,\mathrm{k}\Omega$ is sufficient. Next, the frequency of the input voltage V_{in} needs to be chosen such that the output voltage is measurably but not completely suppressed by the low-pass filter. The so-called Bode plot (see Figure 2.7) contains all information needed to make this decision.

The -3dB point, where V_{out} is suppressed by a factor 2, was chosen, which corresponds to a frequency of roughly 600 Hz. Using $R_x = 82 \,\mathrm{k}\Omega$ and $V_{\text{in}} = V_0 \,e^{i2\pi ft}$ with f = 600 Hz and $V_0 = 10$ V, the resulting output voltage V_{out} has a root mean square (RMS) of 1.3 ± 0.2 V when the low-pass filter is working properly (C = 10 $\pm 2 \,\mathrm{nF}$) and a RMS of 2.7 V when the capacitor is broken (C = 0). This difference can easily be detected by a voltmeter. In addition, this test setup also allows for the distinction between above two cases and the case when an error occurs in the setup, e.g. if there is a short circuit present. In this case the output voltage is simply 0 V.

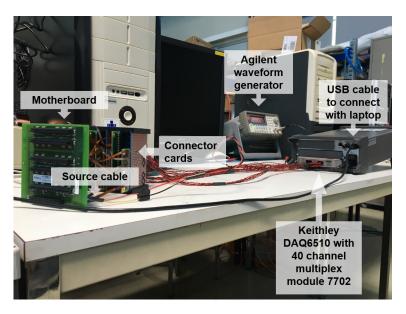
Figure 2.8: Setup for the capacitor test. The AC input voltage is provided by the waveform generator. The output voltage over each channel is then measured by the Keithley DAQ6510 multimeter via the 40 channel multiplex module.

The setup for the capacitor test is shown in Figure 2.8. The input AC voltage is delivered by the waveform generator. The kaptons of the tested motherboard are plugged into the five connector cards displayed in Figure 2.8. In order for the ordering of the channels to come out right, it is crucial that the back sides of the kaptons (with the solder joints) are connected to the back sides of the connector cards (also with solder joints). The connector cards in turn are connected with the 40 channel multiplex module 7702 that is inserted in the Keithley DAQ6510 multimeter device. The script tests/scripts/capacitor_test/Capacitor Test Measurement.ipynb should be running on the computer that is connected to the Keithley device via an USB cable.
